Ohio EPA Incident # 0909-48-2775
River Road Redevelopment Leach-ate
09/22/2009 OSC Gerber
Toledo, Lucas Co.

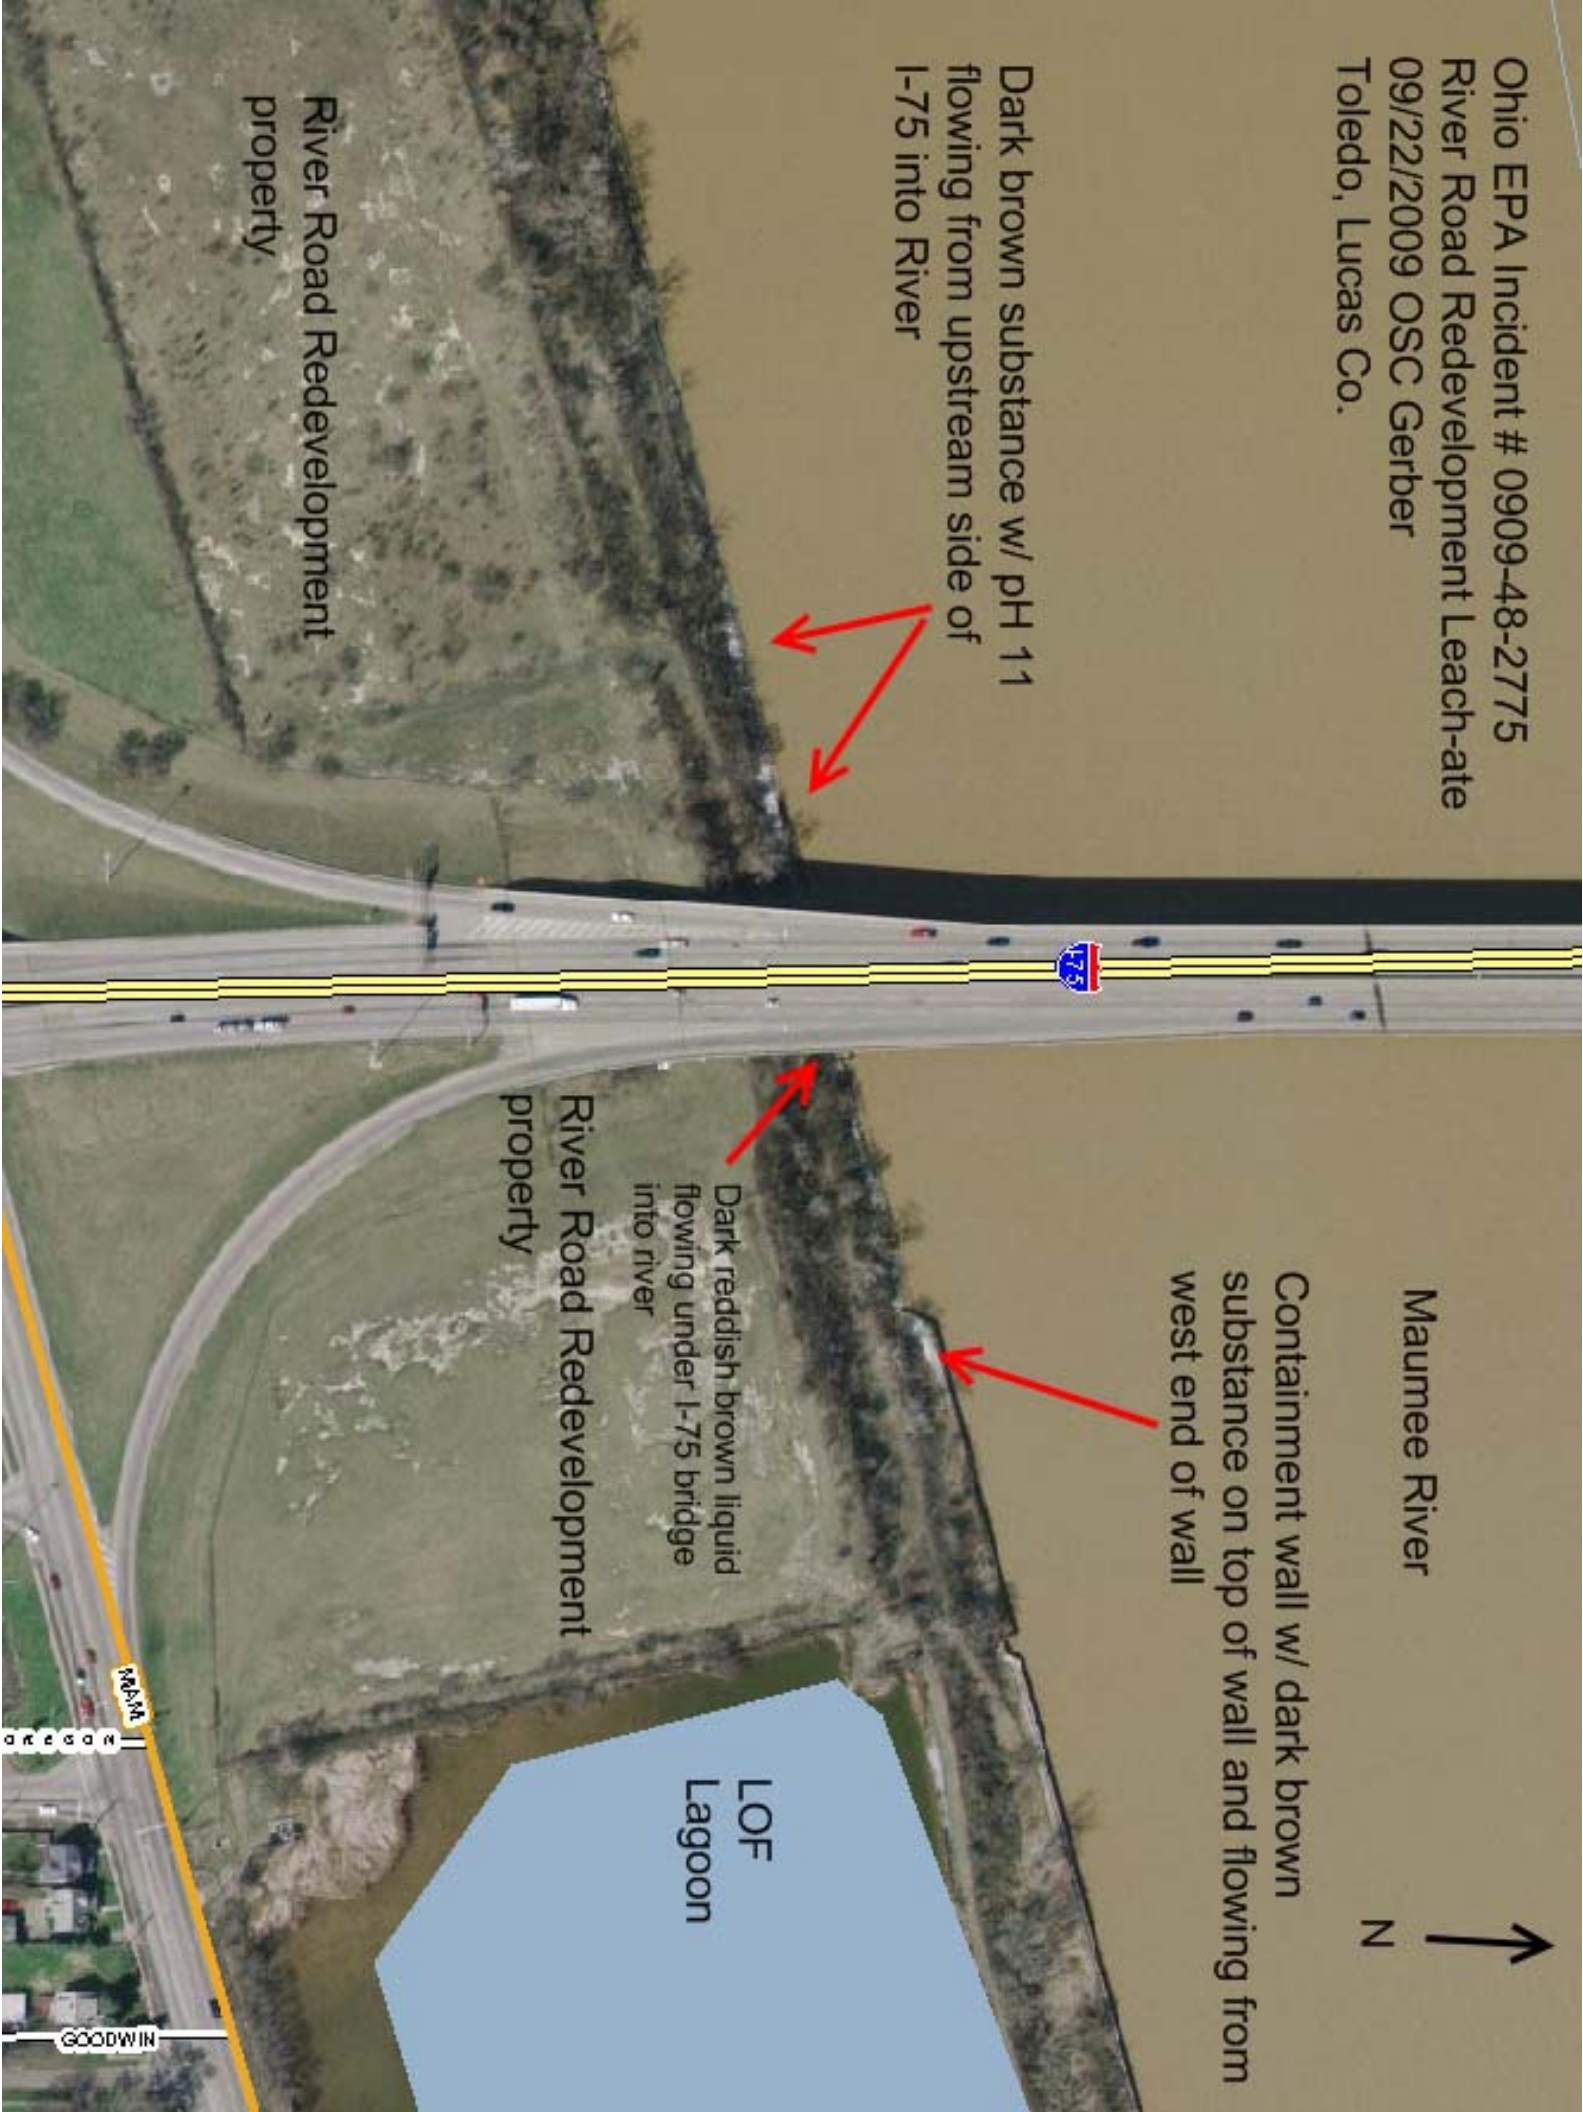
Dark brown substance w/ pH 11
flowing from upstream side of
I-75 into River

Maumee River
Containment wall w/ dark brown
substance on top of wall and flowing from
west end of wall

Dark reddish brown liquid
flowing under I-75 bridge
into river
